CONTAMINATION CONTROL IN HYBRID MICROELECTRONIC MODULES

SELECTION AND EVALUATION OF COATING MATERIALS
FINAL REPORT - PART 2 OF THREE PARTS

APRIL 1975

HUGHES AIRCRAFT COMPANY
CULVER CITY, CALIFORNIA

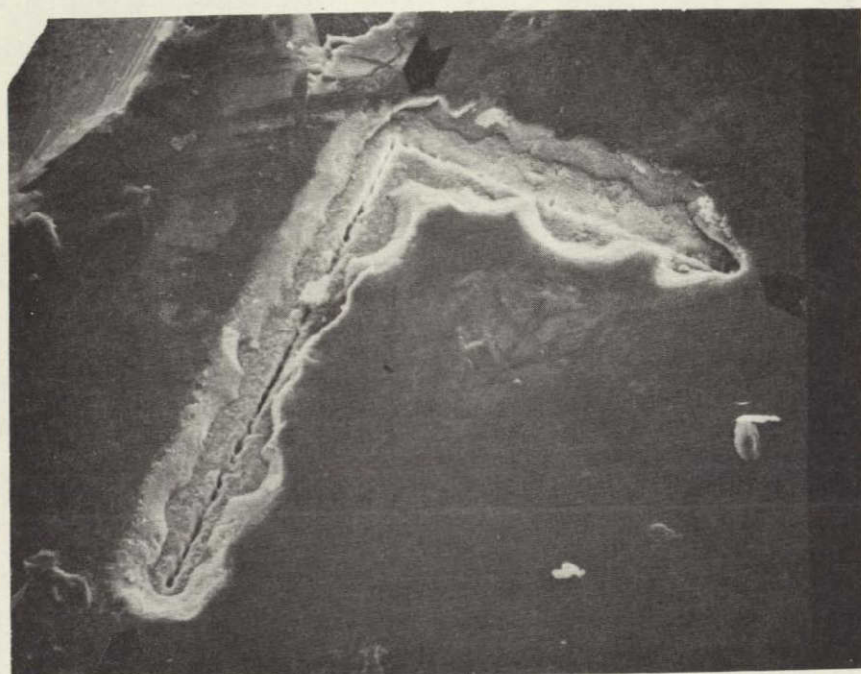
Figure 2. Laser-trimmed thin film resistor through DC 62-047 WE silicone coating (SEM photo at 162X).
